# Corrugated Stainless Steel Tubing (CSST) Questions and Considerations

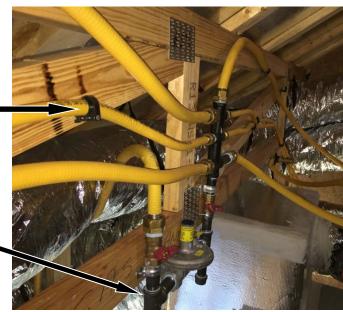
### **CSST** at Manifold with Regulator

Individual branch lines out to appliances/equipment

High pressure main line from meter at building exterior (may be black iron pipe)

- 2) How do I determine whether I have CSST in my home? It is advised that a licensed plumber be contacted to make this determination; however, you can check for yourself by going in the attic and orienting yourself to the location of your gas appliances, then look for the gas line that runs from the building exterior to either a main "trunk" line (typical for black steel gas pipe systems) or to a manifold/regulator station (typical for CSST systems) with multiple ports for individual gas connections. If you have CSST, the individual flexible "hose type" lines will run from the manifold across the attic to the individual appliance locations and down the walls to each of them. The lines will be yellow, or you may have black-colored CSST which would be one of the second-generation products.

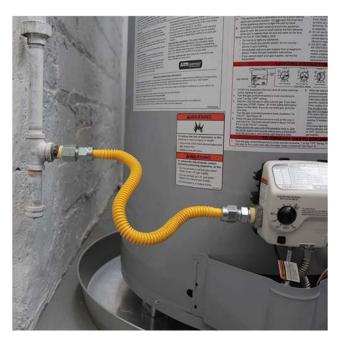
Flexible appliance connectors are used to connect an appliance such as a water heater or furnace to the black iron pipe gas system within a building.

These appliance connectors may be vulnerable to lightning strikes as well, however they are normally located in areas accessible to the building occupants, and their cumulative length (and therefore potential for exposure) is but a fraction of the total length of CSST piping in a typical installation. The potential risks associated with these connectors is also reduced, by the fact that building codes require the black iron pipe gas system to which they are typically attached, to be bonded and grounded.
